**An Aquatic Plant Management Plan Update For
Delavan Lake
Walworth County, WI**

2017

**Prepared by
Audrey Greene and Charlie Handel
Delavan Lake Sanitary District**

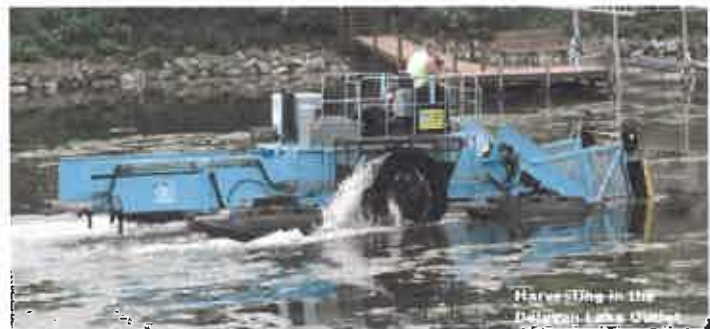
Mechanical harvesters are often described as underwater lawn mowers. They come in a large array of sizes to fit different situations. Moving along predetermined and permitted paths, harvesters cut, collect and remove aquatic vegetation. Mechanical harvesting removes the top layer of plant growth to allow for boat traffic while the remaining plant and root system provide habitat and sediment stabilization. Removing the top growth also removes some of the nutrients tied up in the plant biomass. Depending on the type of plant and the conditions, harvesting may need to be conducted more than one time each year to maintain boating paths.

The Delavan Lake Sanitary District mechanical harvesting equipment includes three harvesters, one high-speed transport barge, three off-loading shore conveyors, one dump truck and three other support vehicles. The maximum cutting width ranges from 7 feet for the two larger harvesters to five feet for the smallest harvester. Each of the three harvesters is capable of harvesting plants up to a maximum depth of five feet.

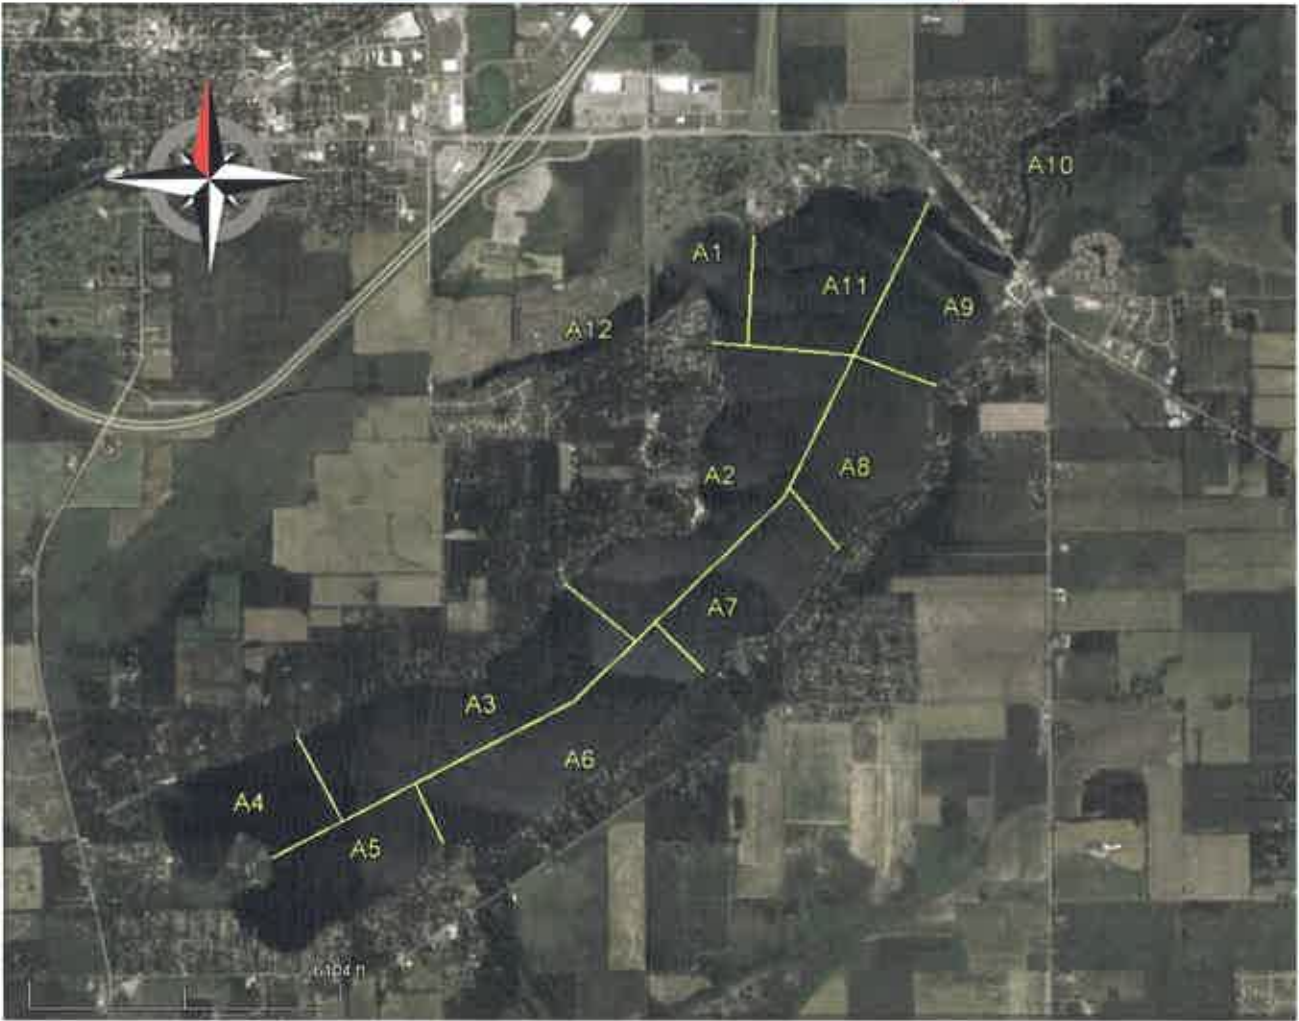
MAP 4
Delavan Lake Harvesting Areas

The recommendations listed in The Aquatic Plant Management Plan and the conditions listed in the mechanical harvesting permit granted by DNR, which expired December 31, 2016, specified that mechanical harvesting be used as the primary control for aquatic plants, with chemical control measures to be limited to control of nuisance growths of exotic species and filamentous algae. The permit also stated that the harvesting of aquatic plants should not mean removing 100% of the plants in the lake, but should only remove nuisance plants in order to facilitate recreational use of the lake. In addition, prior to June 15 of each year, in order to protect newly spawned fish, harvesting was limited to cutting channels only where they are needed to provide boating access to channels and piers. After June 15, harvesting can be expanded as needed.
